# Dual-View Imaging Report

4589 Rendevous Trail  
Steamboat Springs, CO. 80487

Prepared for: John Riley

Prepared by: Complete Home Inspection Services, LLC  
P.O. Box 880018  
Steamboat Springs, CO 80488

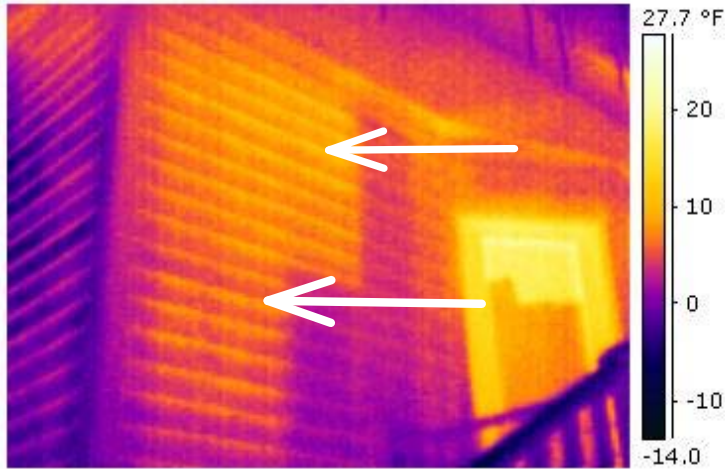
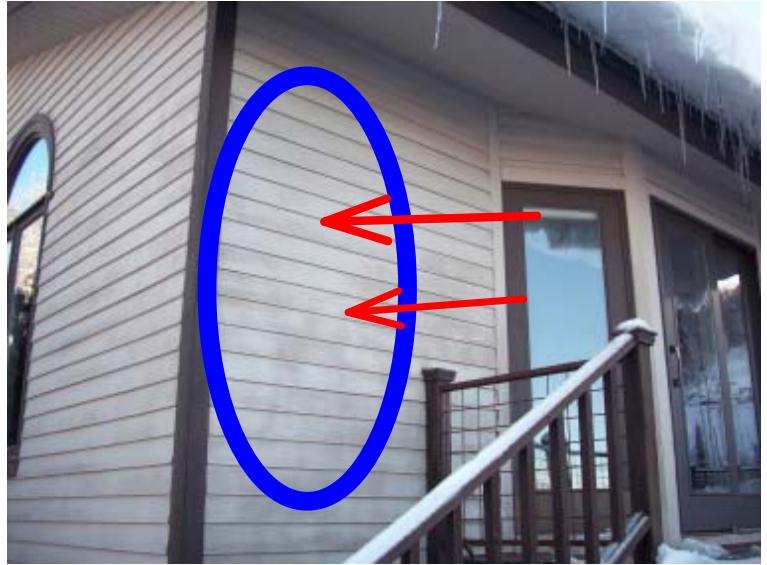
Location Floor: Exterior Wall  
Location Direction: Southwest Corner

These photos indicate missing insulation in the southwest exterior wall.

Observations: These photos indicate missing insulation in the southwest exterior wall.

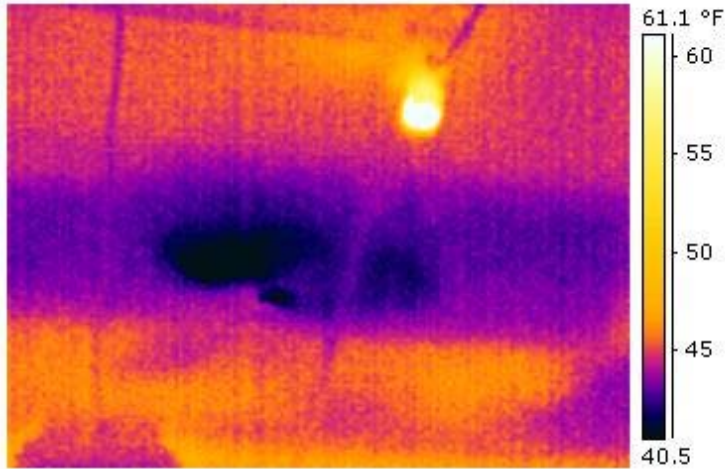
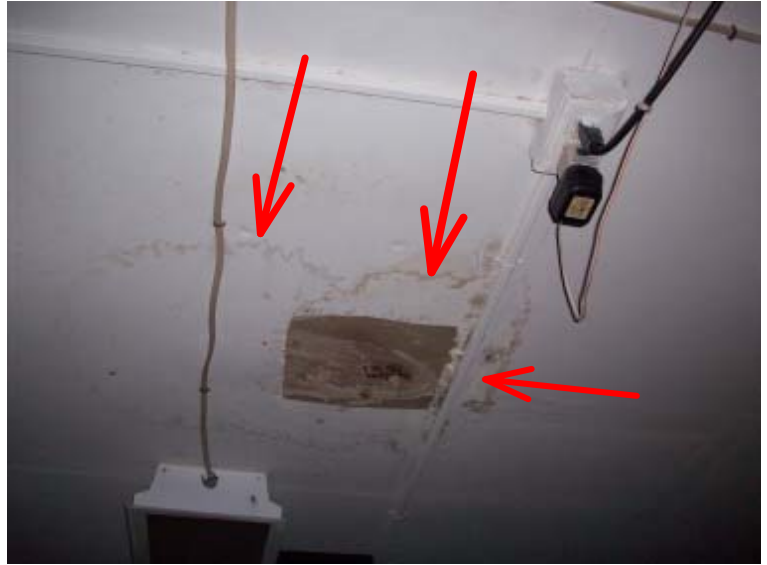
Location Floor: Garage  
Location Direction: Middle Area of Garage Ceiling

These photos indicate moisture intrusion in the ceiling/roof of the garage.

Observations: These photos indicate moisture intrusion in the ceiling/roof of the garage.

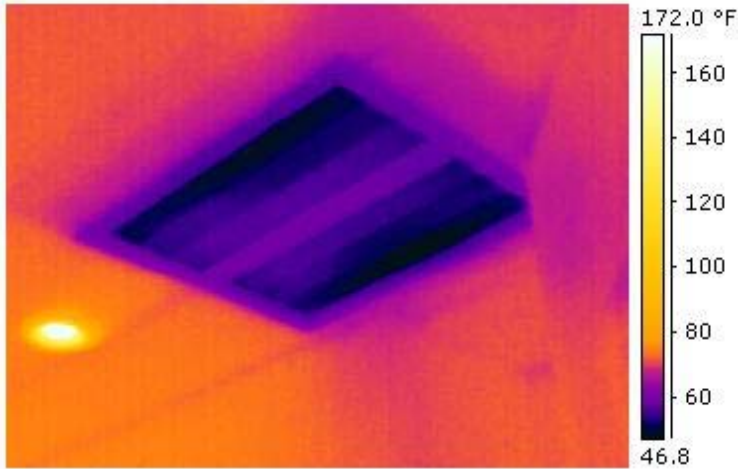
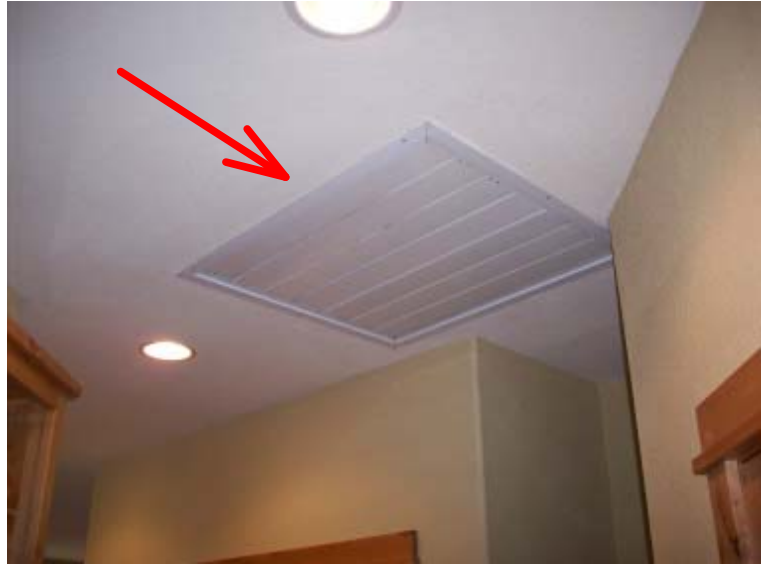
Location Floor: Main Level  
Location Direction: Hallway Ceiling

These photos indicate heat loss/cold air infiltration through the whole house fan opening in the ceiling at the hallway between the kitchen and garage.

Observations: These photos indicate heat loss/cold air infiltration through the whole house fan opening in the ceiling at the hallway between the kitchen and garage.

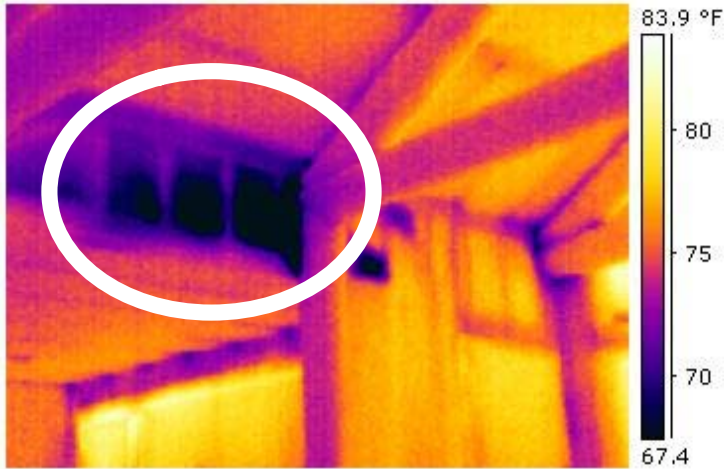
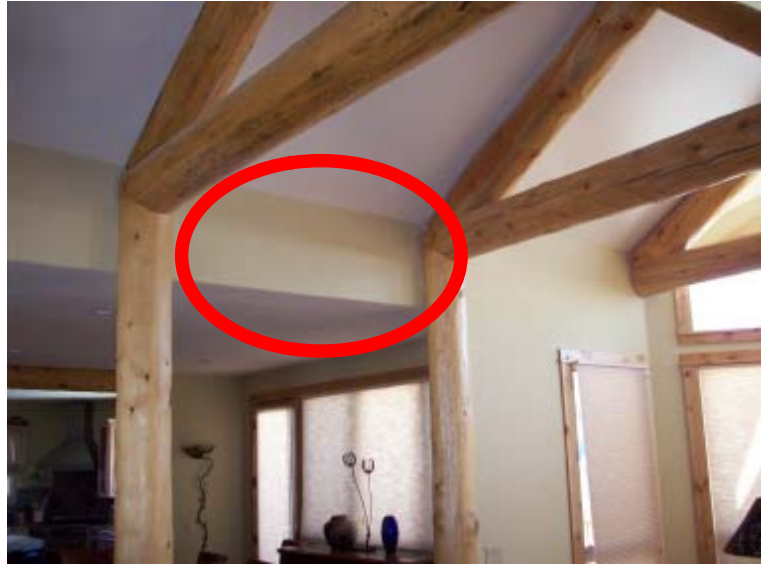
Location Floor: Main Level  
Location Direction: SE Exterior Wall Between Kitchen & Dining

These photos indicate missing insulation in the southeast exterior wall and roof juncture between the kitchen and diningroom area.

Observations: These photos indicate missing insulation in the southeast exterior wall and roof juncture between the kitchen and diningroom area.

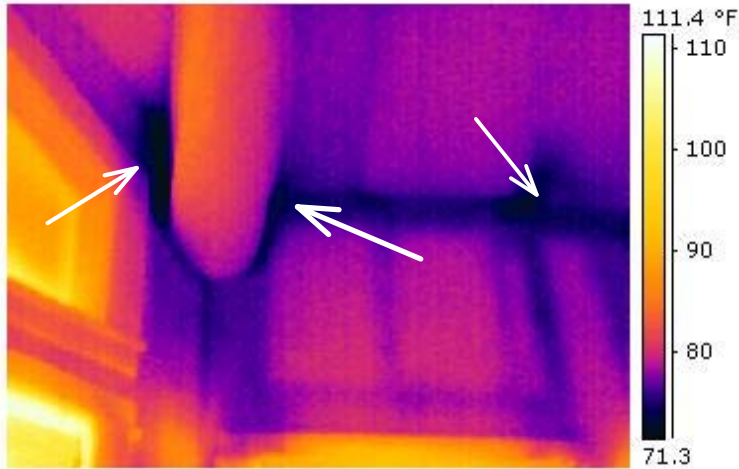
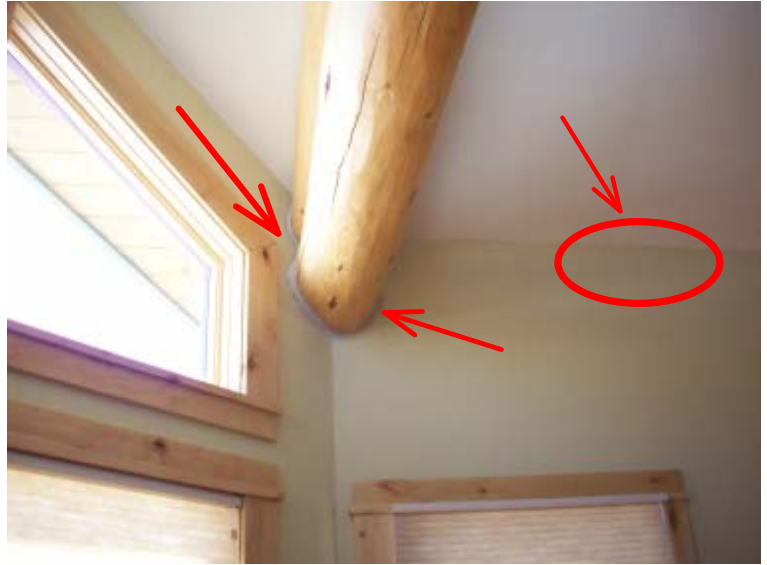
Location Floor: Main Level Living Room  
Location Direction: Southwest Exterior Wall

These photos indicate cold air infiltration at the log beam on the southwest exterior wall in the livingroom. There is a spot where poor or missing insulation is detected in exterior wall to the right of log beam.

Observations: These photos indicate cold air infiltration at the log beam on the southwest exterior wall in the livingroom. There is a spot where poor or missing insulation is detected in exterior wall to the right of log beam.
